# NATIONAL BUREAU OF STANDARDS REPORT

AN INTERIM REPORT ON BOILING TESTS  
OF  
INSULATIONS FOR UNDERGROUND HEAT DISTRIBUTION SYSTEMS

1003-20-4881

October 28, 1958

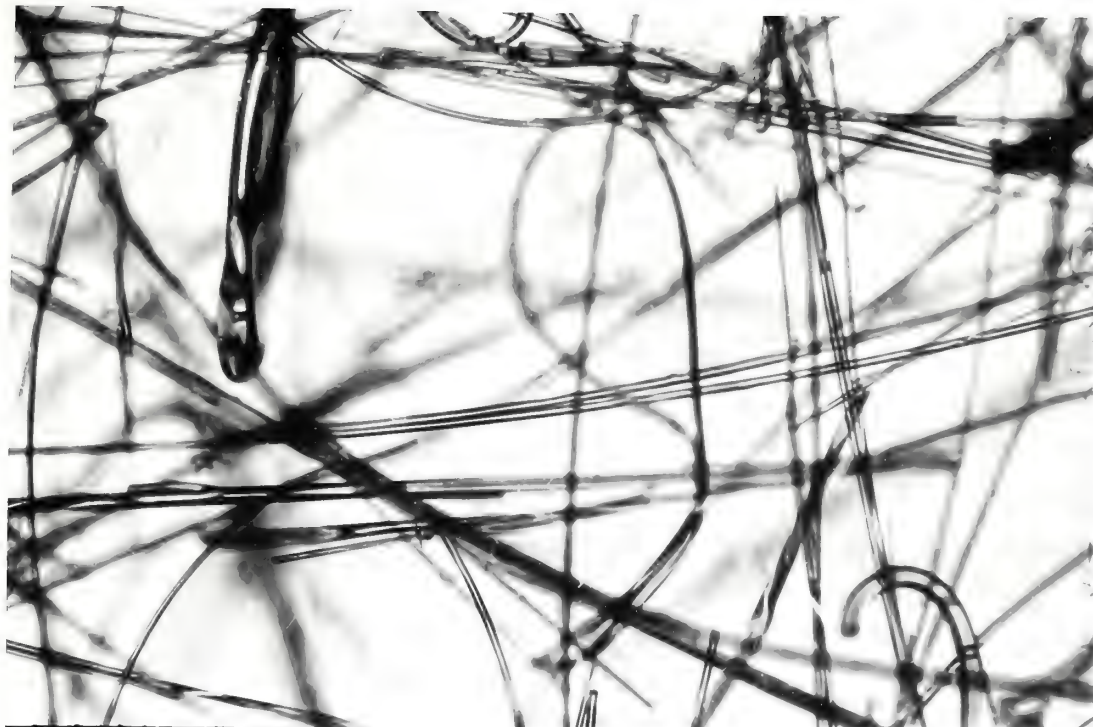
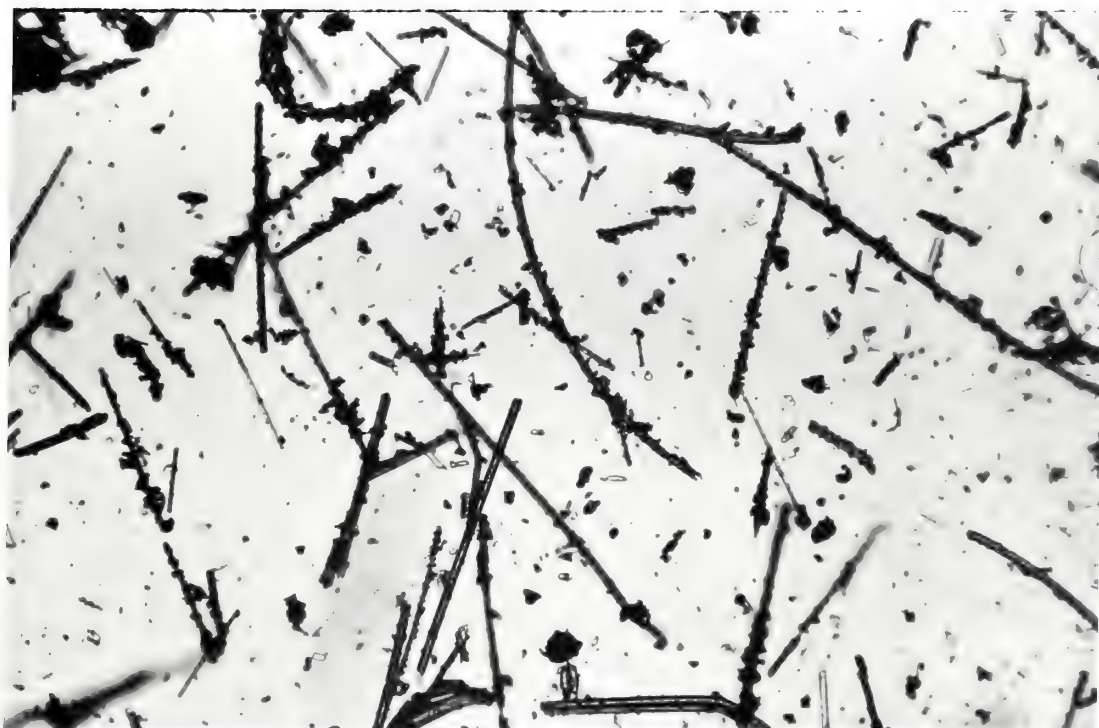
Microscopic Examinations of Insulation: Samples of insulation were taken from the specimen at several locations after the test for microscopic examination. Microphotographs were taken of the glass fibers before and after boiling. Fig 16a shows the smooth, transparent, cylindrical appearance of the fibers when new. Fig 16b shows the appearance of the material near the surface of the envelope after boiling. It was broken into many short pieces, and appeared brown to the naked eye (perhaps the effect of the boiling water and steam on the oil treatment of the original material). Fig 16a and 16b are about 400 to 1 magnifications.

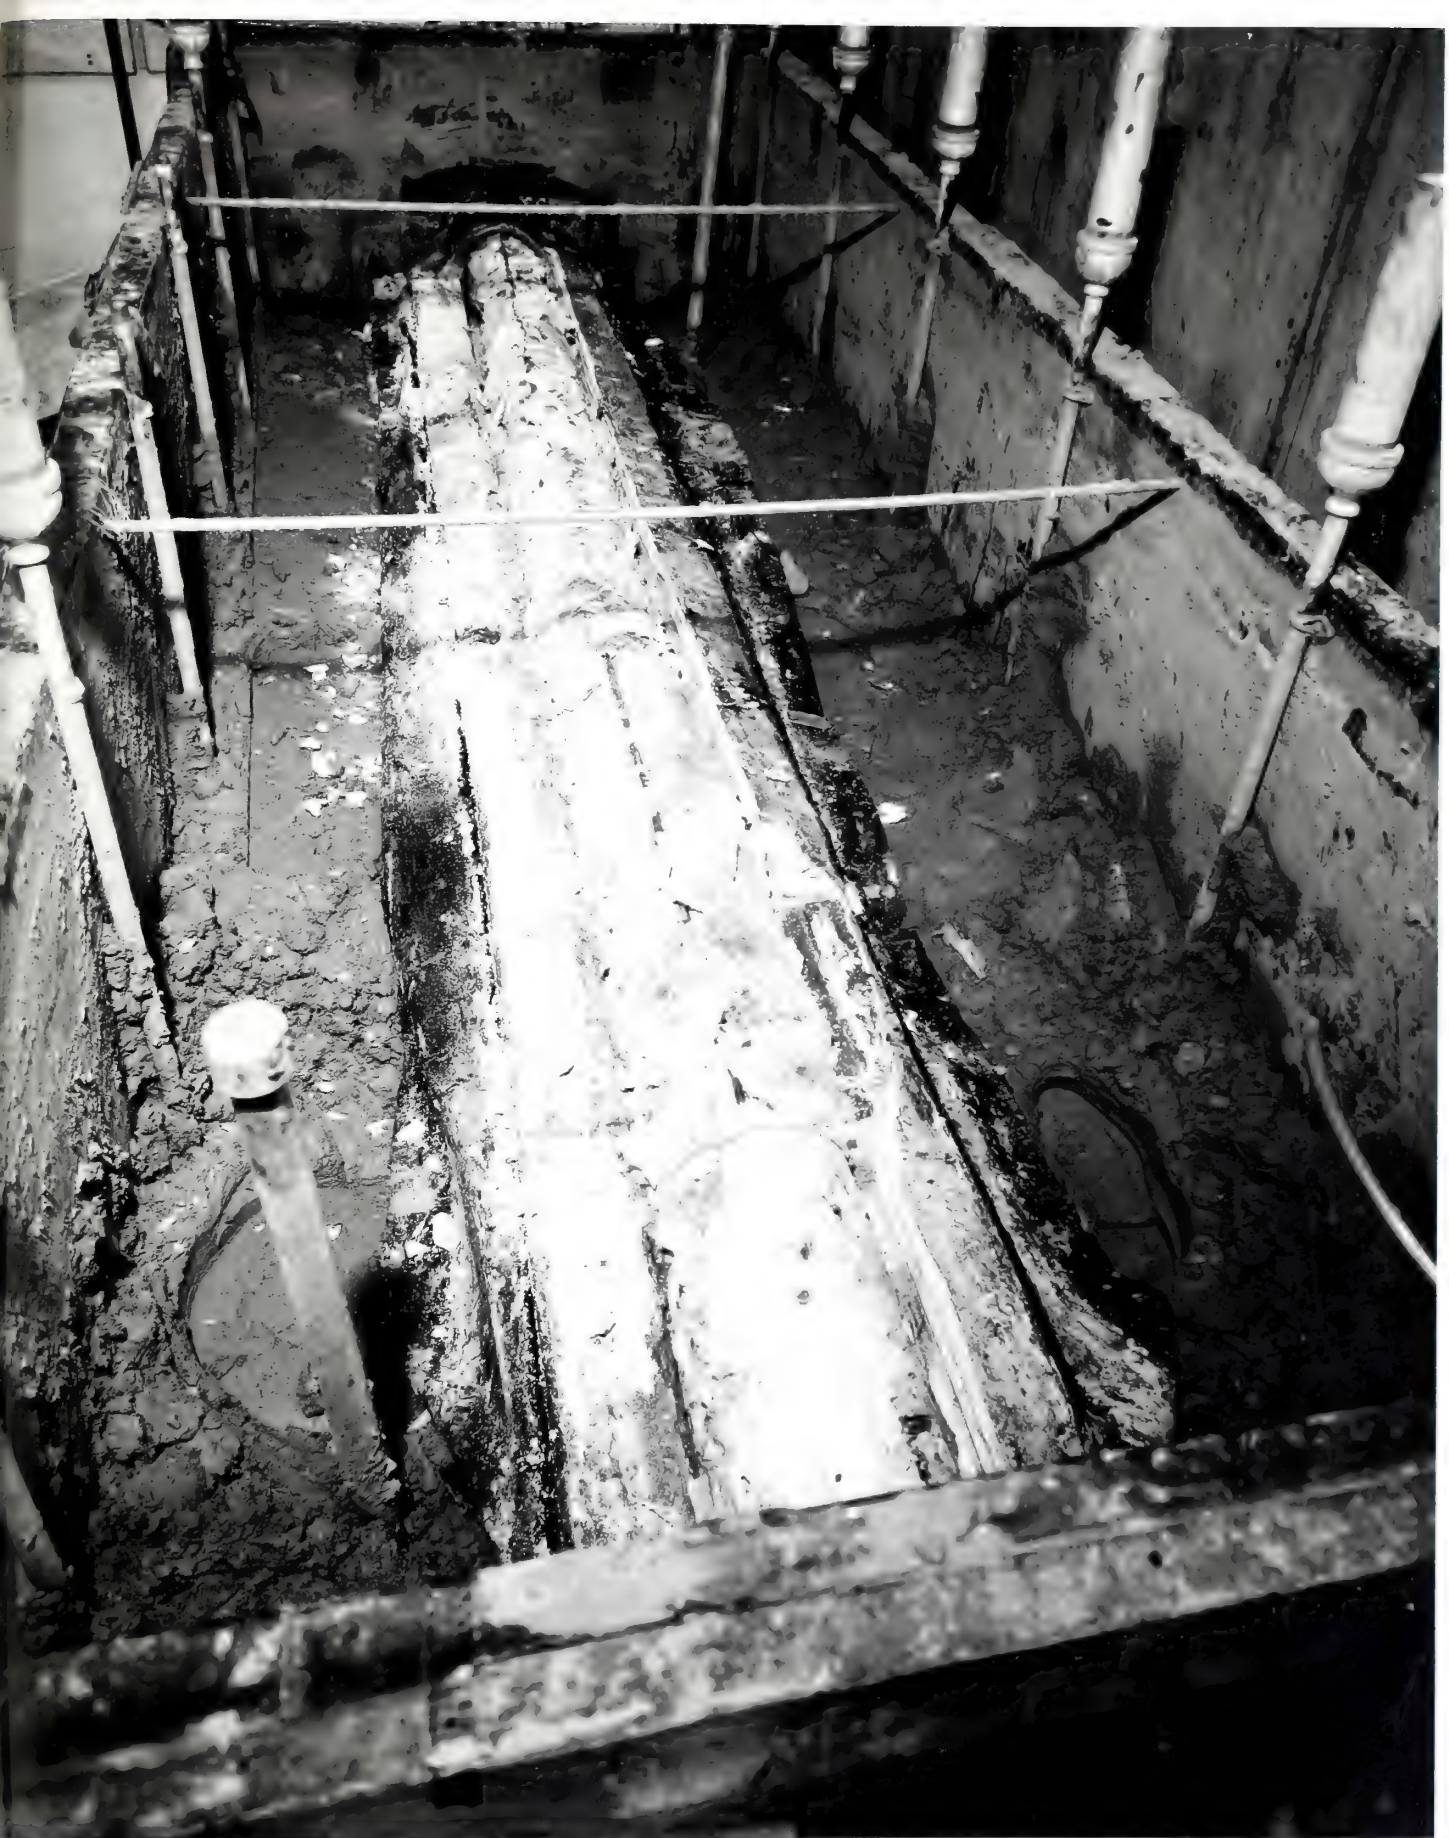
Figure 19

Fig 19 shows the appearance of the insulation in the conduit after boiling 72 hours. The dark streak at top center is a copper tube used at one time to introduce water to the insulation.

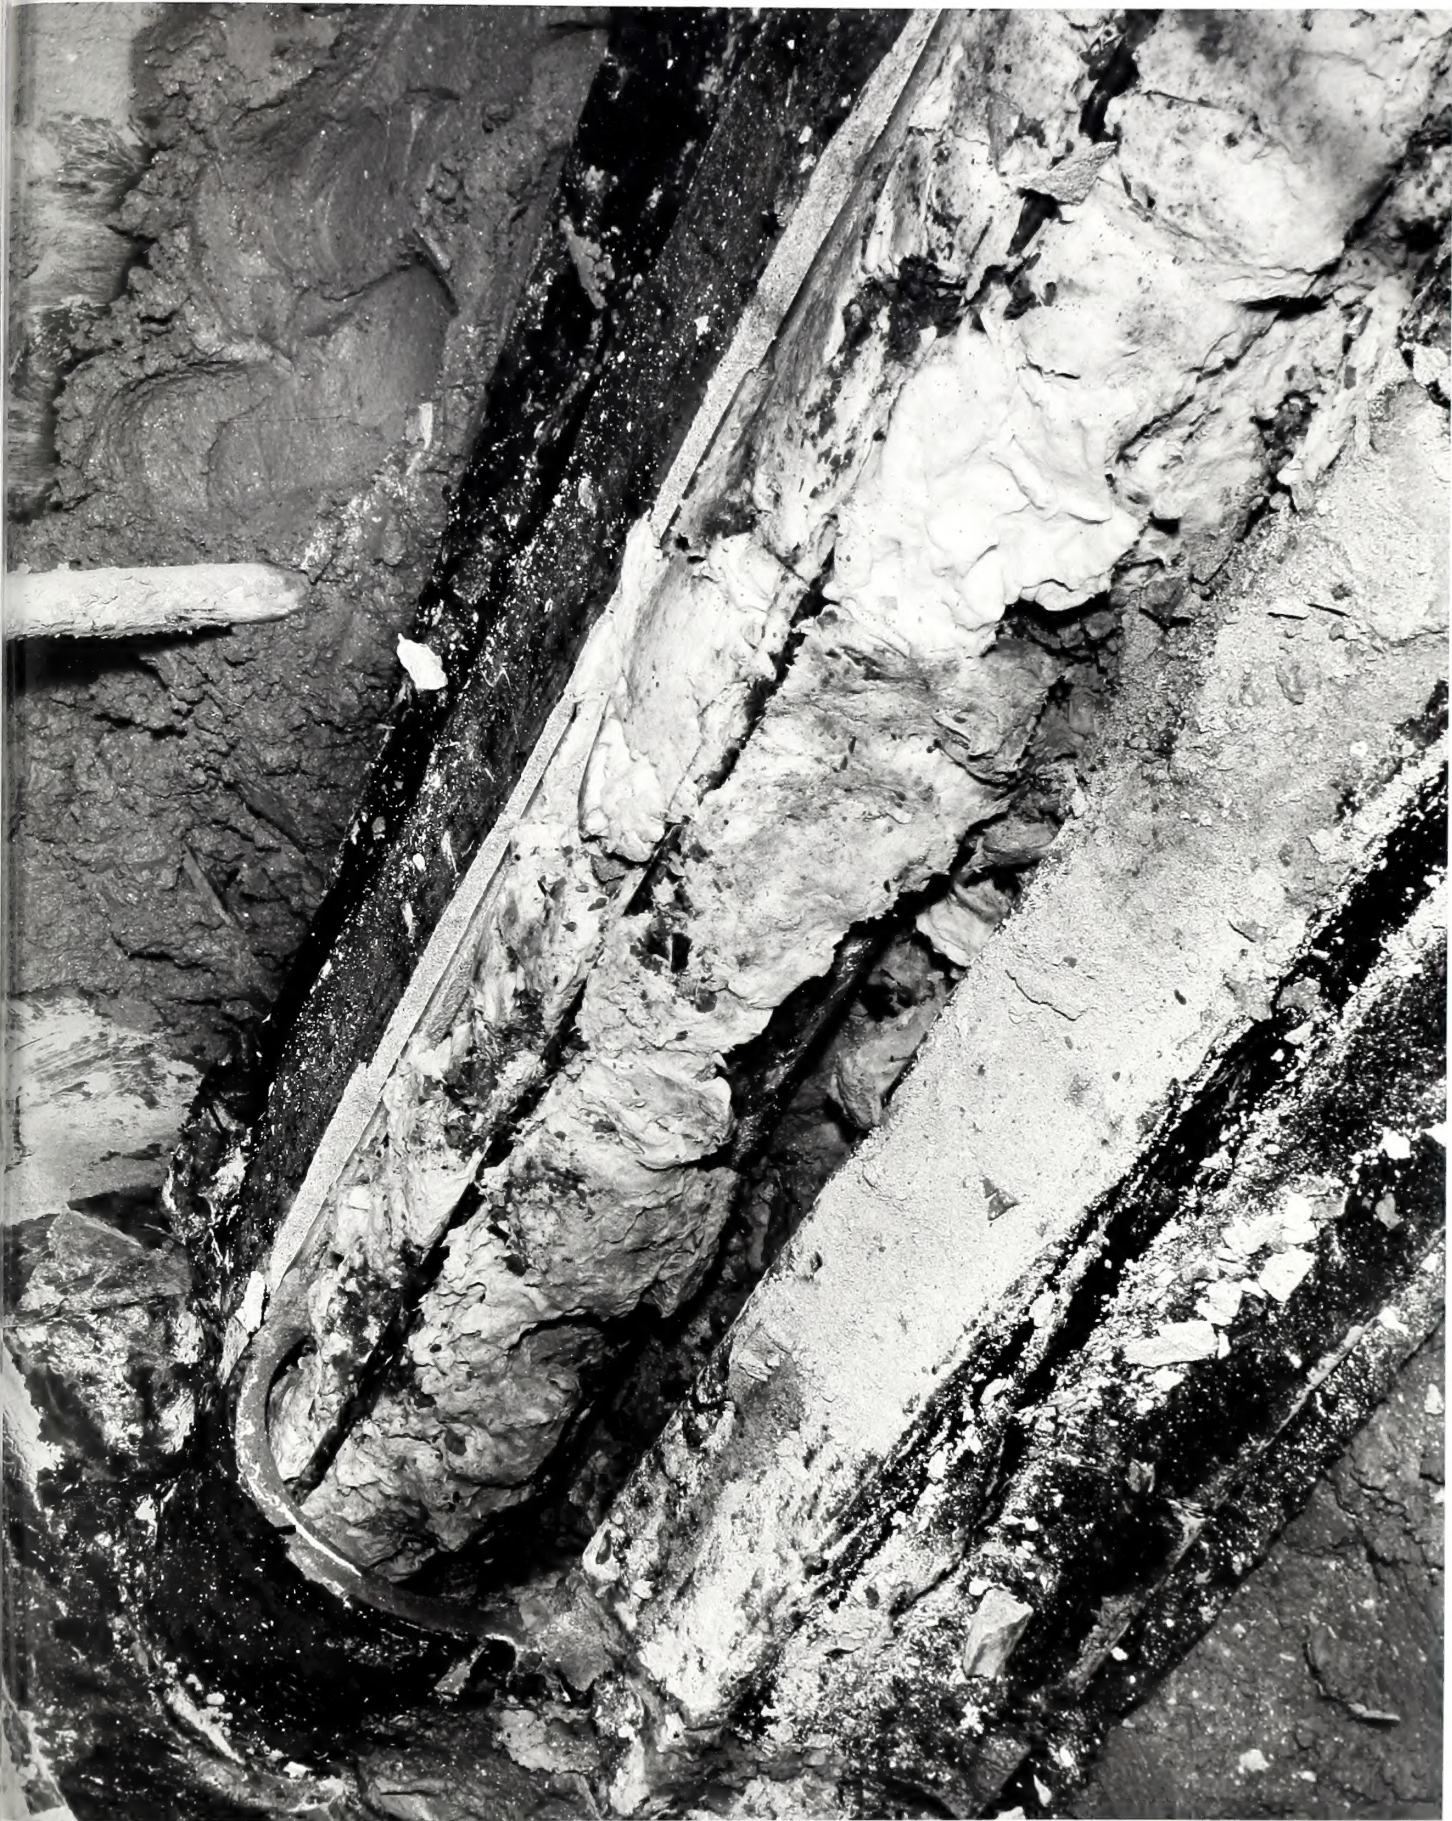
Figure 20

Fig 20 shows the appearance, at the downstream end, of the insulation. The 4 in. pipe is exposed for about 1/2 of its circumference on the lower side. There was considerable loss of insulation only near the outlet end for a distance of about 3 ft. A small amount was also lost at the inlet end. Apparently the insulation was carried out of the vertical vent pipes by the surging water and steam. Some pulverized glass fibers were found in the vent pipe at the end of the test. Except for the loss indicated above, there was little evidence of any voids in the remainder of the insulation.
